Failure Analysis & Mechanism Studies of the Worm-like Defects in Vias of Wafer Fabrication

Hua Younan*, Liao Jinzhi Lois, Liu Binghai, Zhu Lei, Li Xiaomin

WinTech Nano-Technology Services Pte. Ltd., 10 Science Park Road, #03-26, The Alpha Science Park II, Singapore 117684

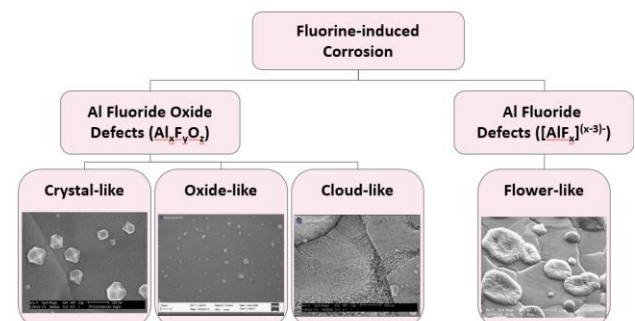
Figure 1: The F-induced corrosion defects were classified as the “flower-like”, “crystal-like”, “oxide-like” and “cloud-like” defects.

For example, we have deeply studied the F-induced corrosion defects and proposed the related failure models, and made classification for the F-induced corrosion defects on the Al bondpads as the “flower-like”, “crystal-like”, “oxide-like” and “cloud-like” defects as shown in

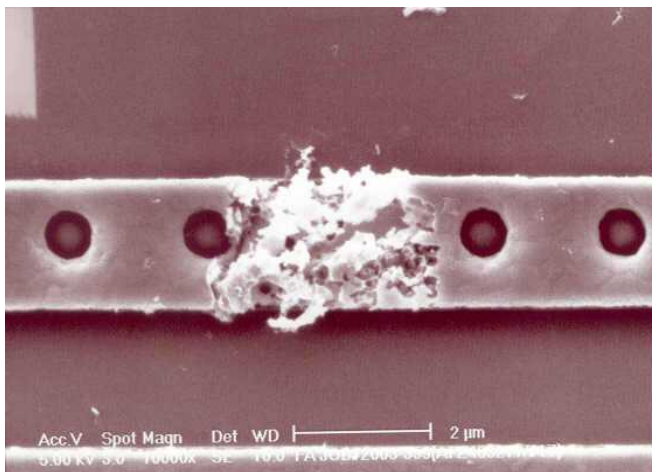
Figure 2: SEM micrograph showed the corrosive defect on Al metal line due to Cl-induced corrosion.

Figure 2 shows a Cl corrosive defect on the Al metal line. One can see that the defect has damaged the metal line, which may cause low yield or reliability issue. The root cause was identified to be Cl environment contamination. It is understood that differencing from F-induced corrosion, Cl-induced corrosion is immediate. Moreover, AlCl₃ is a chemically unstable compound and it dissolves in water. Therefore, Cl-induced corrosion is more serious as it can cause chemical chain reactions (see discussion in the next session).

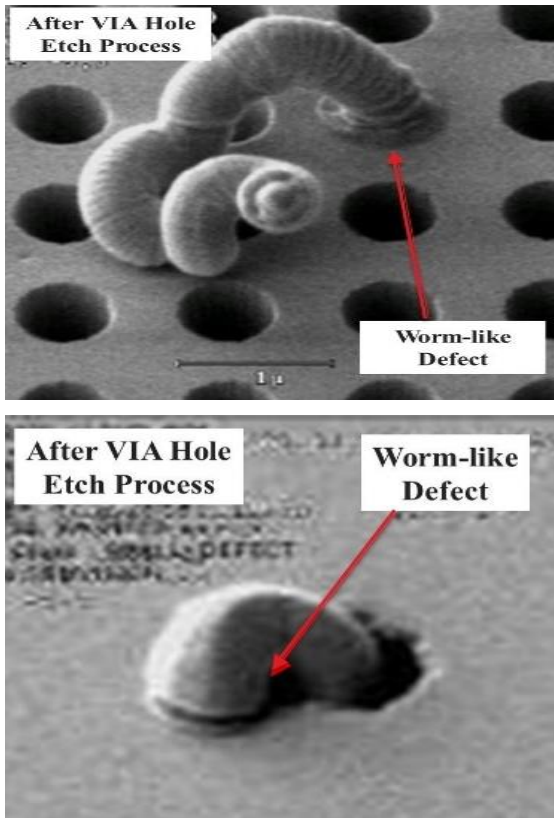
Inline SEM inspection after VIA hole etch process revealed the formation of bountiful worm-like defects, protruding from via holes, as shown by the SEM images in Figure 4. With the presence of these worm-like defects will definitely affect the subsequent processes like deposition of the barrier layers and W layer. In order to the understand the root-cause behind the formation worm-like defects, we performed detailed failure analysis and failure mechanism studies.

Figure 4: The Worm-like defects were found in Via holes after Via hole etching processes in wafer fab. At the bottom of the via holes, it was Al M1.

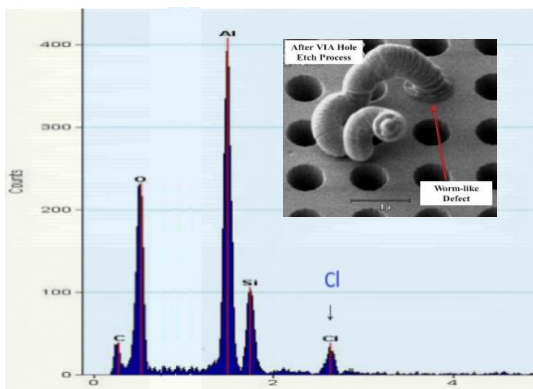
Figure 5 shows the micro-area EDX analysis on the worm-like defect. As shown in Figure 5, a small amount of Cl was detected, indicating that the worm-like defect was formed due to Cl-induced corrosion. Further FIB-SEM analysis showed that the worm-like defects directly grew from the bottom Al M1 layer along the via holes.

Figure 5: EDX on the Worm-like defect detected Cl peak and confirmed that it was Cl-induced corrosion defect.

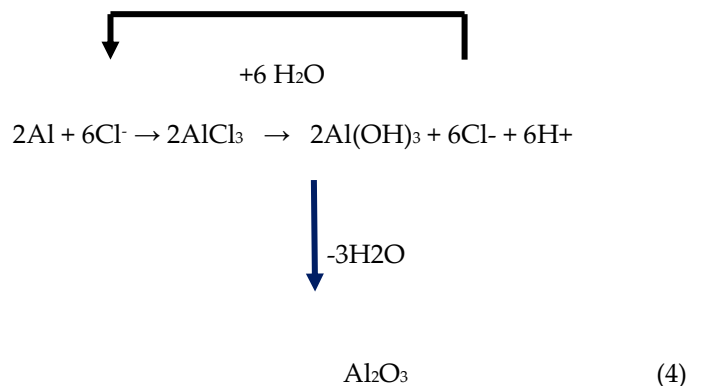
In the production process of wafer fab and via holes, Al of M1 reacts with Cl to generate aluminium trichloride (AlCl₃). Because aluminium trichloride is water soluble. Therefore, when it encounters water vapor, a further chemical reaction can produce HCl, which is later decomposed into Cl ions again. The Cl ions could further react with Al to form aluminium trichloride. This repeated chemical reaction process is so-called "Cl-chain chemical

reaction". As a result of the "Cl-chain chemical reaction", only a small amount of Cl ions could propagate in chemical reactions repeatedly, and finally it causes very intensive Cl corrosion reactions even with a small amount of Cl ions.

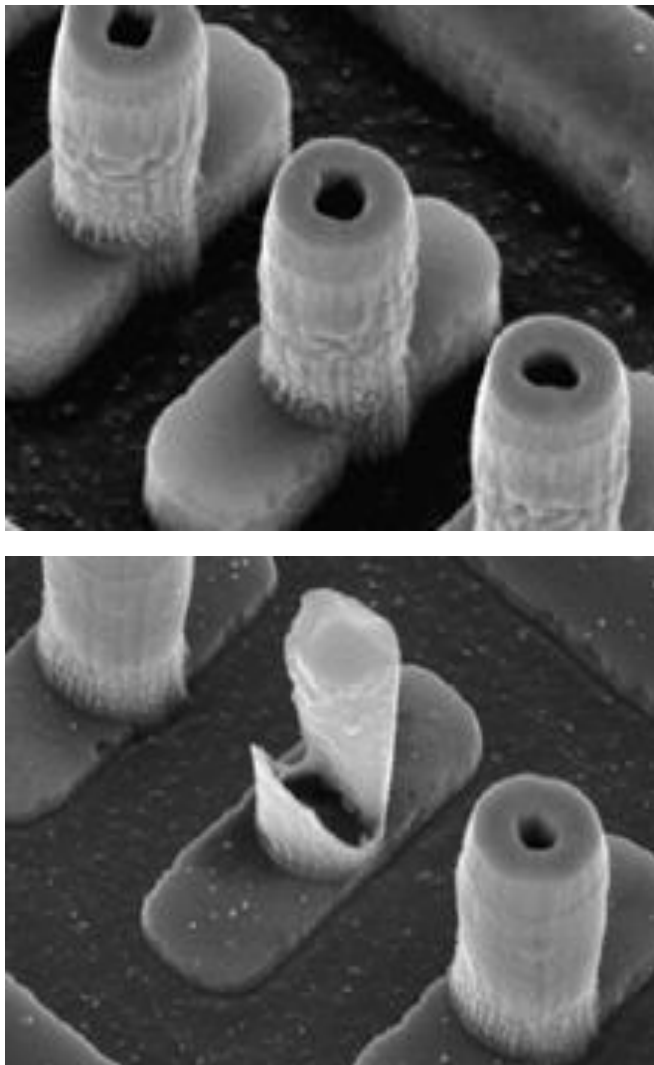
Figure 6: The delayering results showed in good area, the Vias had good metal filling (up), but in bad area, partial via filling was observed due to the worm-like defect (down).

For the failure via structures, we performed the failure analysis by deprocessing (delayering), and then top-down and cross-sectional SEM analysis. Figure 6 showed the top-down SEM images after deprocessing. As shown by Figure 6, the good Vias essentially showed good metal filling (up of the Figure 6), but in the bad area, one Via showed apparent partial filling due to the worm-like defect (down of Figure 6).

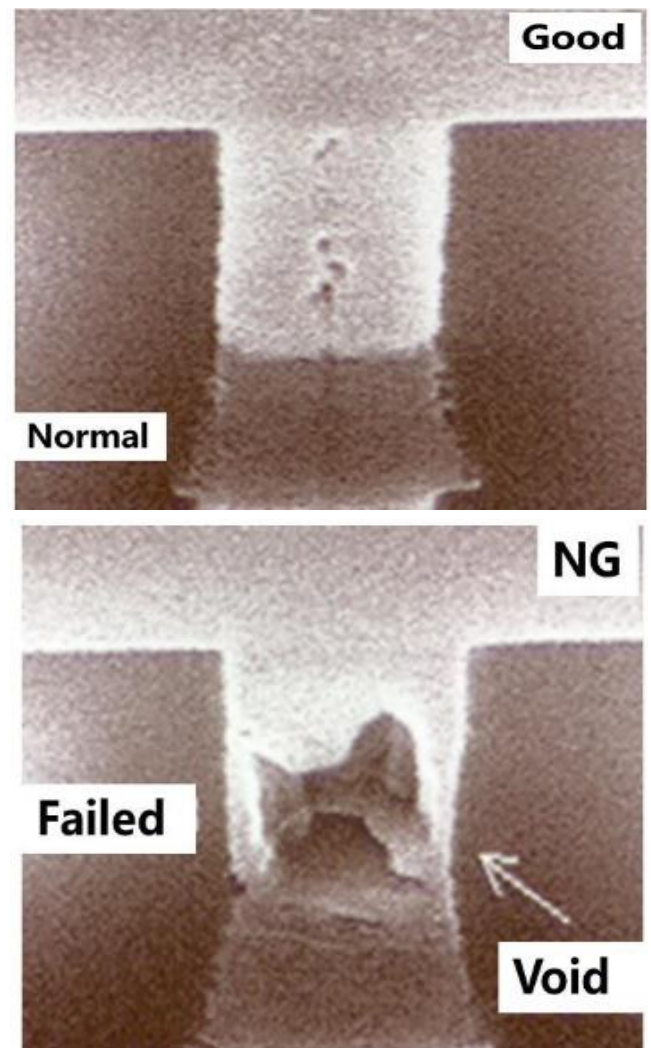
We also performed cross-section FIB (focused ion beam)-SEM analysis. The cross-sectional SEM analysis results were shown in Figure 7. It is clear that the via in the affected lots showed partial filling with a big void at the via bottom (down of the Figure 7) and the FIB-SEM result showed that in the good sample without the worm-like defect, the Via was completed to fill in (up of the Figure 7).

Figure 7: FIB cross sectional result showed that in the good sample without the worm-like defect, the Via was completed to fill in (up). But non good (NG) sample with the worm-like defect, the Via was not completed to fill in and with the void (down).

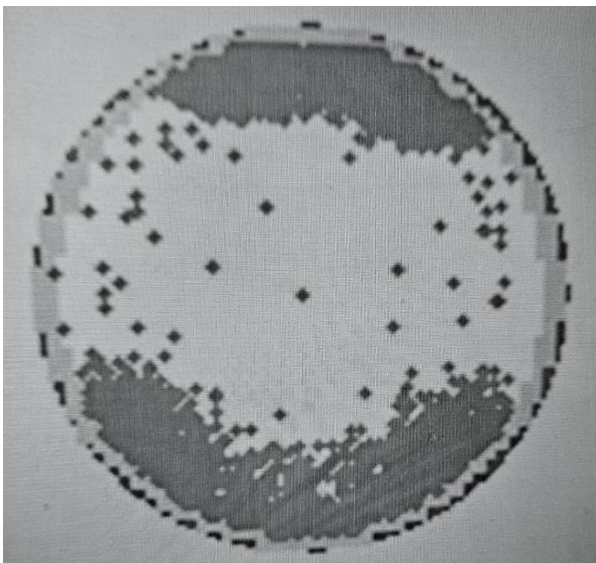
Inline investigations and analysis reveal interesting characteristics of the worm-like defects. KLA scan maps of the affected wafers showed a distinct bracket signature (refer to Figure 8). There was also no single wafer orientation or alignment with respect to the notch. Another characteristic was that the first slot was typically the most severely affected wafer compared to the rest of the wafers in the lot. It has also been observed that the occurrence of the worm-like defects was intermittent with no common tool, device/part, or layer. It also occurred even with environmental Cl levels safely below the specification limit.

Figure 8: KLA scan map of the wafer affected with the worm-like defects showing bracket signature.

Based on the abovementioned characteristics of the defect, residual chlorine is believed to have originated from the mini-environments (SMIF pod) used to transport the wafers during IC fabrication. After etch, the photoresist is removed by plasma resist strip (PRS) process. In the PRS tool, there is a possibility of pod switching. For instance, a SMIF pod may contain wafers that have undergone polysilicon etch which uses Cl-based etchant gases (refer to Table 1). As a result, the SMIF pod traps residual Cl. After the PRS step, it is possible for wafers with exposed Al metal to be contained in a Cl-contaminated SMIF pod that was previously used during polysilicon etch, a Cl-based etch process. The residual Cl inside the contaminated pod attacks the exposed Al metal in the presence of ambient moisture and forms corrosion products as discussed in the earlier section.

The distinct bracket signature in KLA scan maps matches the exposed sections of the wafers when placed inside the cassette (see Figure 4). In other words, only those sections exposed to the SMIF pod are affected with worm-like defects.

As the topmost wafer is the most exposed wafer, it is also the most severely affected, hence producing the “first wafer” effect. These observations reinforce the theory that corrosion is due to SMIF pod contamination. A feasible solution therefore is to eliminate the possibility of pod switching between a pod used for Cl-based etch process and a pod with exposed Al metal.
